MARINE STRUCTURES
THEIR DETERIORATION AND PRESERVATION

REPORT

COMMITTEE ON MARINE PILING INVESTIGATIONS
of the DIVISION OF ENGINEERING AND INDUSTRIAL
RESEARCH *of the* NATIONAL RESEARCH COUNCIL

WILLIAM G. ATWOOD and A. A. JOHNSON

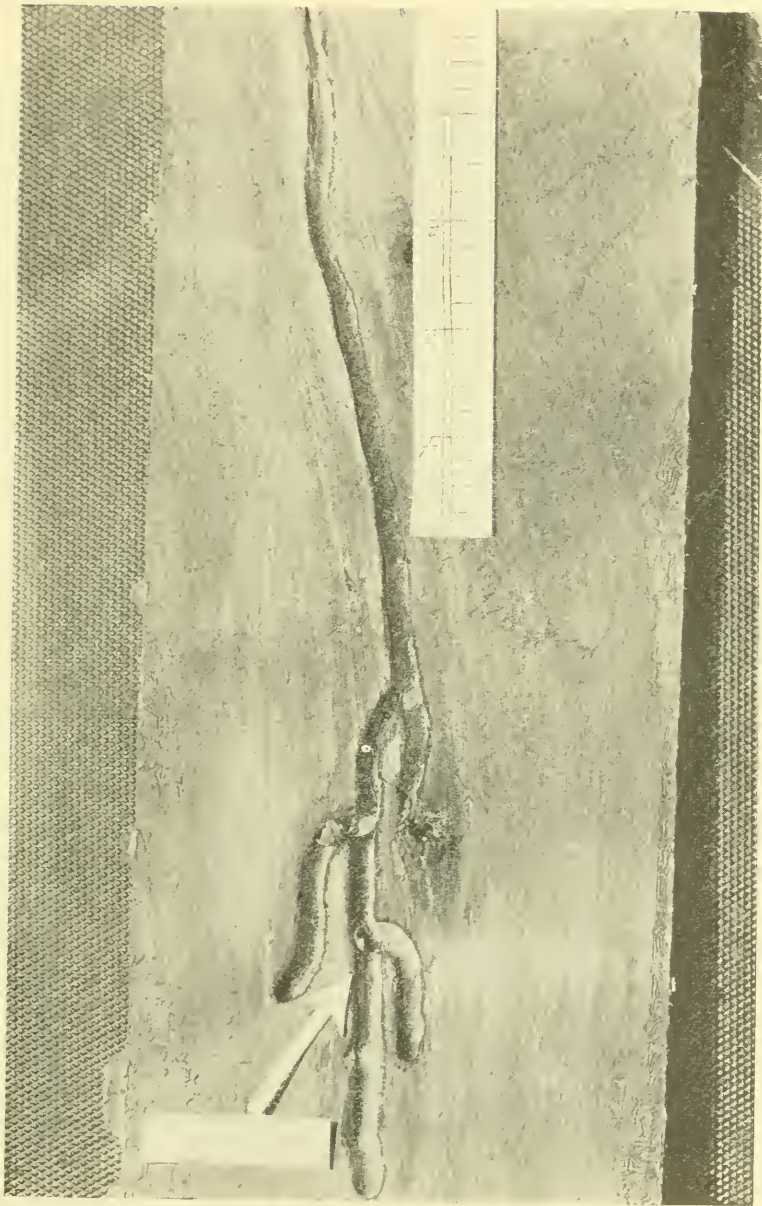
FIG. 5—BURROW OF *Teredo bartschi*; IN SHINGLE BLOCK FROM PORT EADS, LA.

not normal, being less in diameter and longer than usual. They had no difficulty in crossing from one shingle to another, but except in a few cases seemed to prefer to stay in one shingle as long as possible. In one or two cases they seemed to work freely at right angles to the face of the shingles, and were then more nearly normal in shape (Fig. 5).

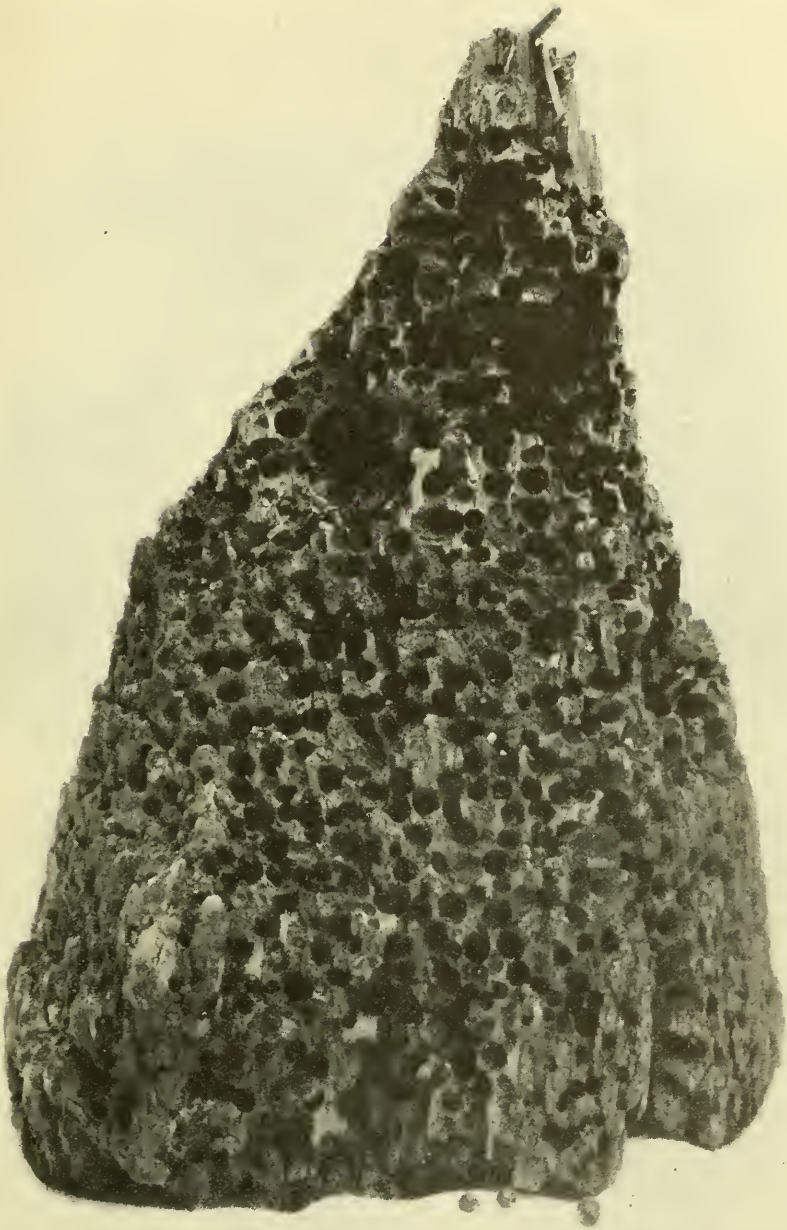
FIG. 12—SECTION OF PILE FROM FLORIDA EAST COAST RY. BRIDGE, ST. JOHNS RIVER, PALATKA, FLA. *Sphacroma* ATTACK—17 YEARS' SERVICE.

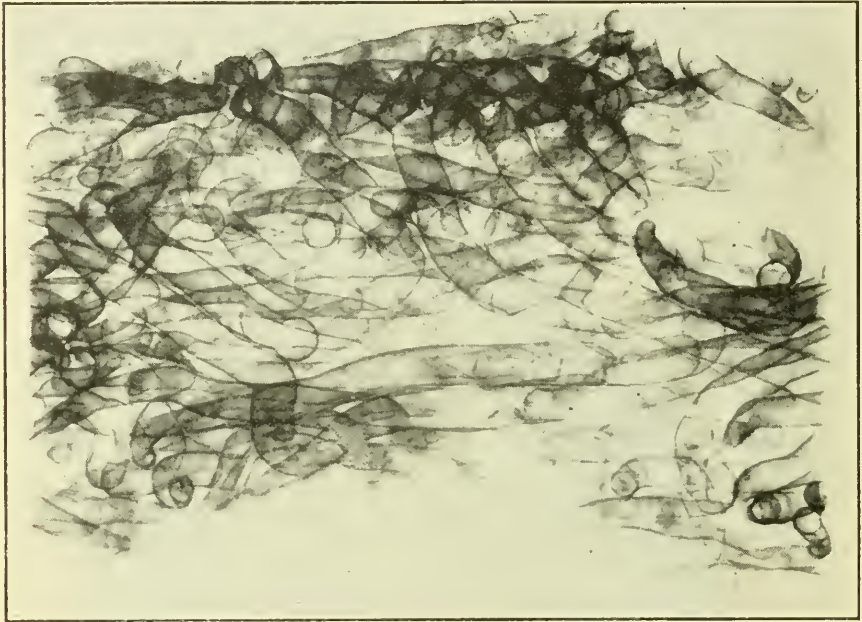
The method of attack and general appearance of the first two genera are similar (Fig. 13). The two valves of the shell function as a highly specialized boring mechanism; the long slimy worm-like body fills the burrow, which is lined with a calcareous coating, and both *Teredo* and *Bankia* are supplied with very long siphons and with so-called "pallets."

FIG. 13—X-RAY PHOTOGRAPH OF TIMBER ATTACKED BY TEREDINE BORERS

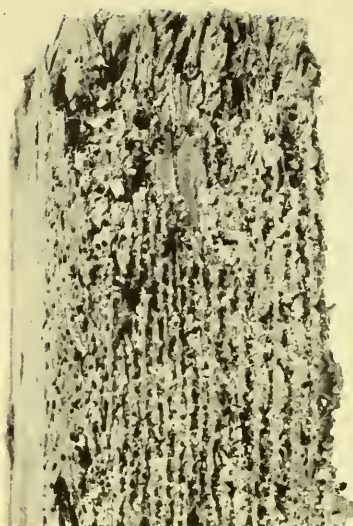
FIG. 6

- FIG. 6. Portion of a $3\frac{1}{2}$ " x $3\frac{1}{2}$ " x 6" test block submerged 8 months at Tutuila, showing damage done by *Limnoria andrewsi* and *Chelura insulae*. The ends of a few *Teredo* burrows have been exposed. x $\frac{3}{4}$.
7. All that remained of a 2" x $3\frac{1}{2}$ " x 5" test block submerged 8 months in Honolulu Harbor. The major damage was occasioned by *Limnoria andrewsi*; *Limnoria lignorum* and *Chelura insulae* were also present in the block. All *Teredo* were dead as a result of exposure of their burrows by the crustacean borers. x $\frac{3}{4}$.
8. Portion of block from Tutuila, showing specimens of *Chelura insulae* in place in burrows. One *Limnoria andrewsi* is seen in place near lower left corner. x 5.

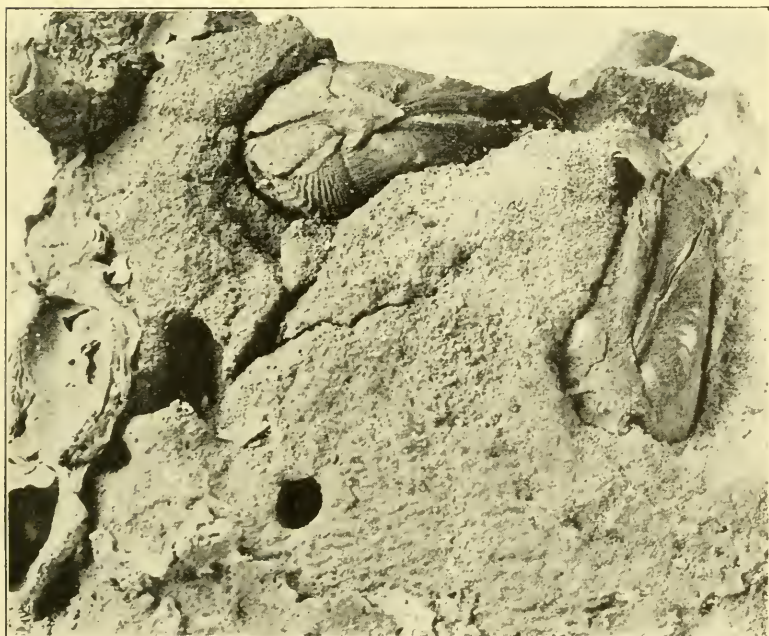
"The species occasioning most of the damage was found to be *Pholadidea penita* Conrad, known commonly as the "rock clam." (Fig. 18.) It occurred from two feet above mean low water to one foot below, which was the lowest level at which we were able to work. It doubtless similarly occurs on down to the mud, even in deep water, as it has been dredged in San Francisco Bay at a depth of fifty fathoms.

"As regards extent of the damage occasioned by borers in concrete, a review of the data assembled by Mr. Hughes, Mr. Ludlow, Mr. Sadler and Dr. Miller, indicates that, of concrete jacketed piles at four different locations in Los Angeles Harbor, in fact at every point in the inner harbor where such piles exist, about 50 per cent have been more or less attacked, of which rather more than one-fifth have been very considerably bored. Of those not attacked, a number stood so well inshore as to be but little exposed to the action of the borers. If all such piles were eliminated from the count, the percentage of jackets damaged would be considerably higher.

FIG. 18—PHOLADS IN CONCRETE CASINGS AT LOS ANGELES, CAL.

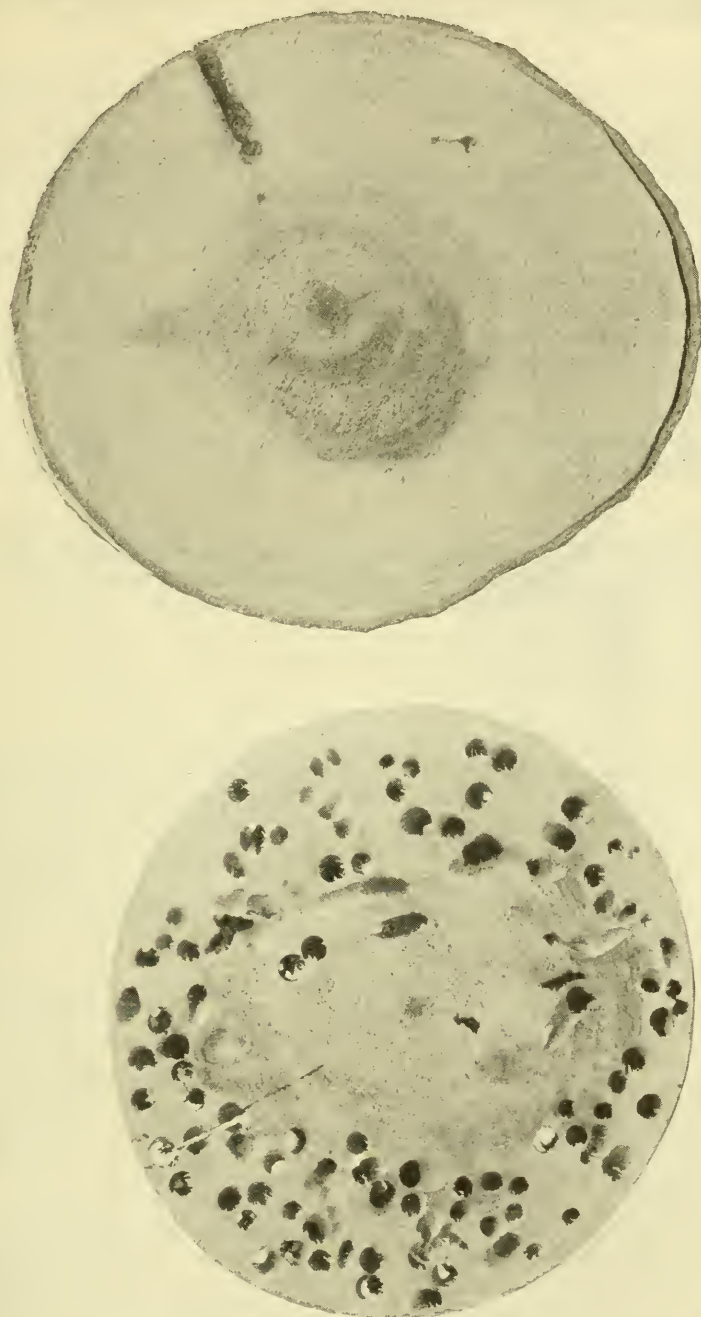
FIG. 20—SECTIONS OF BARKED AND UNBARKED COTTONWOOD TEST PIECES IMMersed AT PIER 1, NORTHERN PACIFIC RY., SEATTLE, SEPTEMBER 27, 1923 AND REMOVED JANUARY 28, 1924

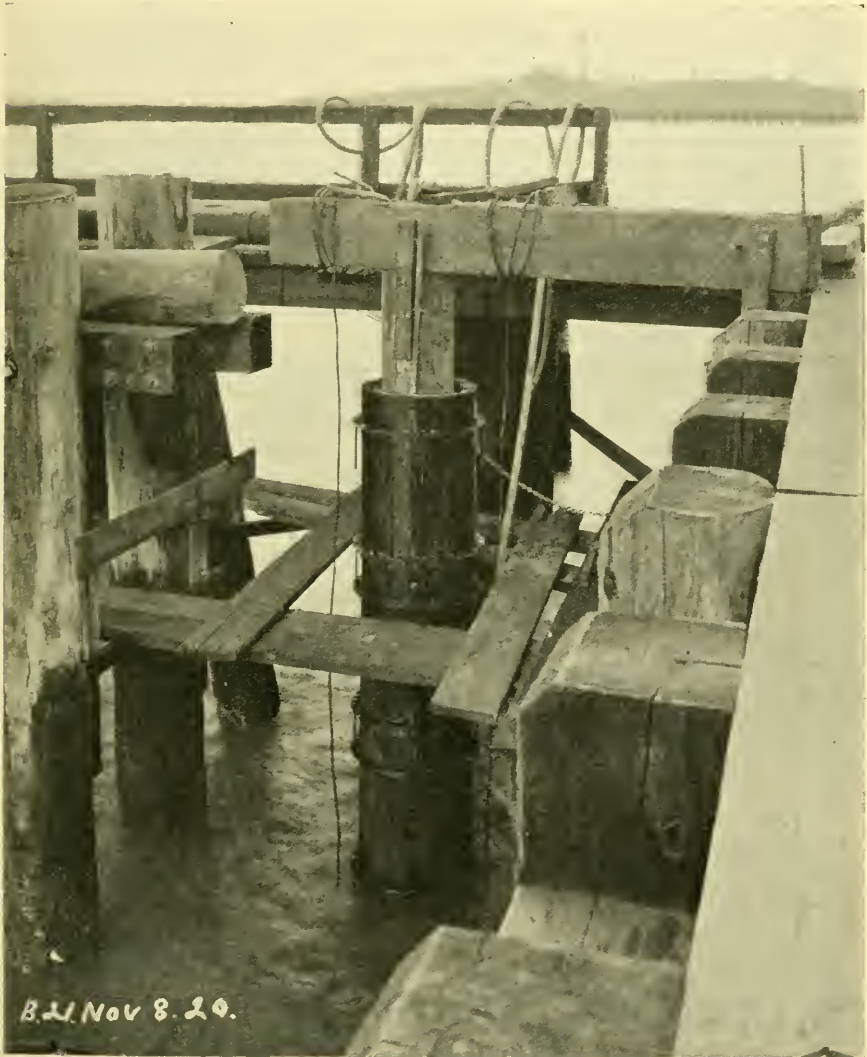
The Camp Process (patented) is typical of the construction of concrete jackets with removable forms (Fig. 24). Circular wooden forms are provided with sections 3 feet in length and about $20\frac{1}{2}$ inches inside diameter, made of tongued and grooved wooden pipe staves strengthened with bands of angle iron. They are made in halves and each half is hinged in the center. When placed around the pile the halves are fastened together with tapered pins. The lower section is provided with sheet iron fingers over which canvas is fastened, and which touch the pile when the form is in place.

FIG. 24—FORMS IN PLACE FOR CONCRETE CASINGS CAST IN PLACE. "CAMP SYSTEM."

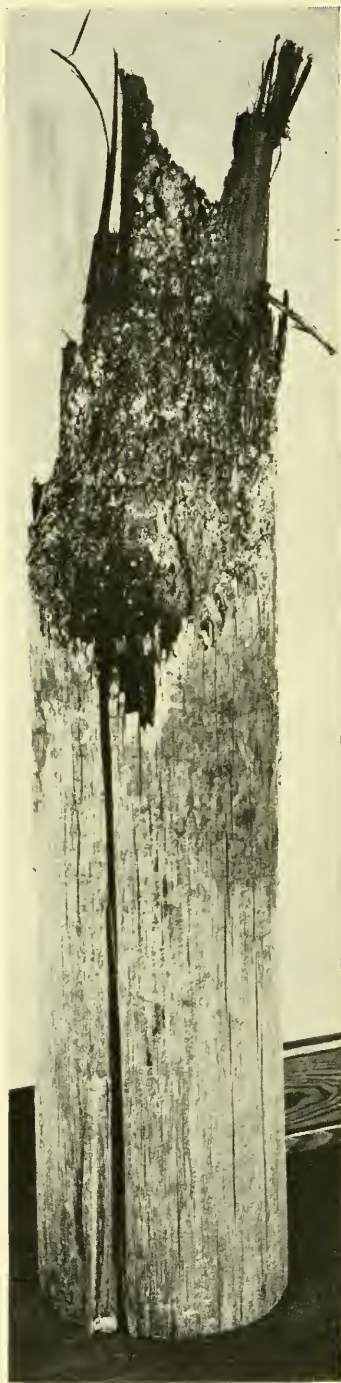
Specimen No. 4—From Pensacola Naval Station, Pensacola, Fla. Pine pile driven in 1902. (Fig. 26.) Specifications required absorption of 20 pounds of creosote per cubic foot. One hundred and ninety-eight piles in structure. In 1906 five piles were so badly damaged as to require renewal, and entire structure is now unsafe. Destruction was caused mainly by *Bankia* and *Limnoria*.

FIG. 26—SECTION OF PILE FROM PENSACOLA NAVY YARD SHOWING WORK OF MARINE BORERS.

One hundred and ninety-eight of these piles treated with 20 lb. per cu. ft. creosote were driven in 1902. At the end of three years five were badly attacked, necessitating the removal of two. Report of September, 1922, states that "all of the piles driven in the work are in such condition that quite a few have been broken off at about approximately water level by wave action. A large majority of the remainder can be broken off at the same level without much difficulty."

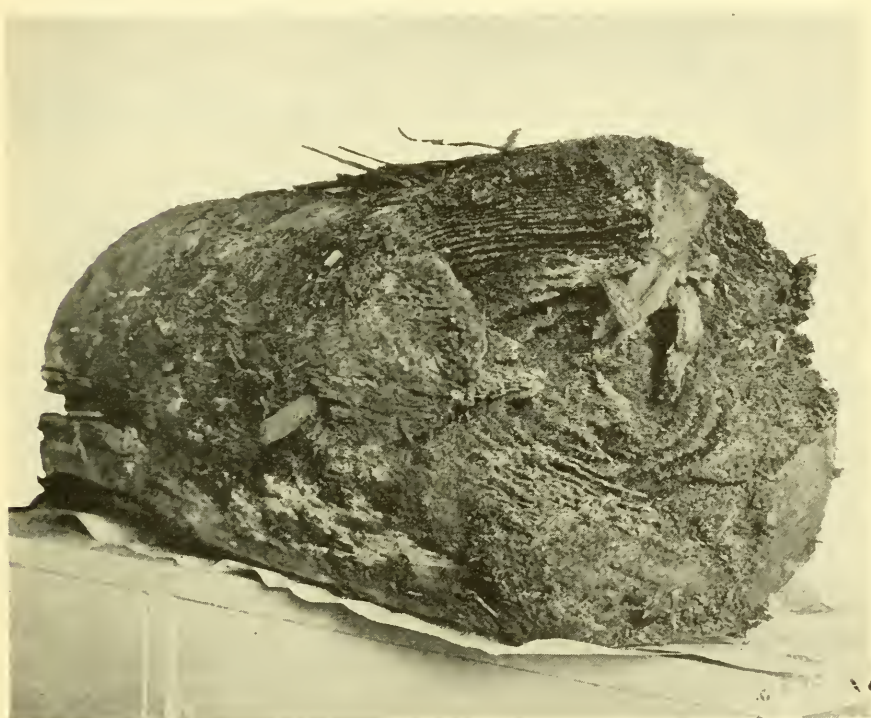
Specimen No. 8—From Lighthouse Pier at San Juan, Porto Rico. No record of treatment available. (Fig. 28). It had 8 years' service and was destroyed by *Limnoria*. It was cut up for other species and none were found.

FIG. 28—SECTION OF CREOSOTED PILE FROM LIGHTHOUSE WHARF, SAN JUAN, PORTO RICO, TAKEN FROM LOW WATER LINE.
Built, 1898—Renewed, 1906

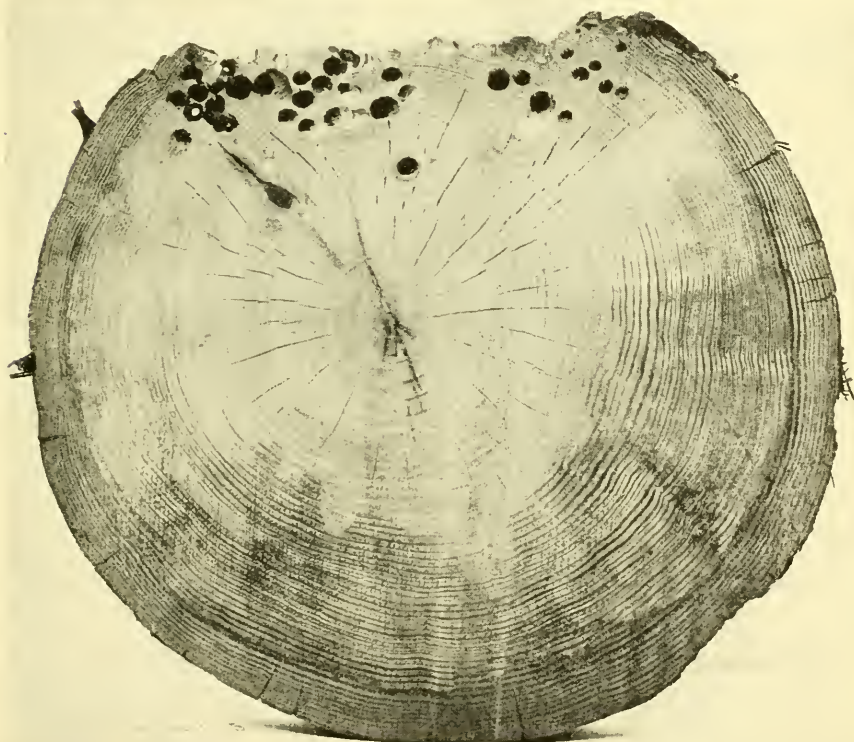
Specimen No. 9—Section of pine pile from foundation of 150-ton revolving crane at the plant of the Newport News Shipbuilding Company. (Fig. 29). These piles were treated by the Norfolk Creosoting Company in 1897 with a 16-pound treatment. The creosote was purchased under the following specification:

On account of the importance of this foundation it has been inspected frequently and carefully. Shipworm attack first appeared about 1920, or after 23 years' service, and the pile analyzed was removed in 1922, after 25 years' service.

FIG. 29—PILE SECTION WITH 16 LB. CREOSOTE TREATMENT. 25 YEARS' SERVICE IN 150 TON CRANE FOUNDATION, NEWPORT NEWS SHIPBUILDING & DRY DOCK CO., NEWPORT NEWS, VA.

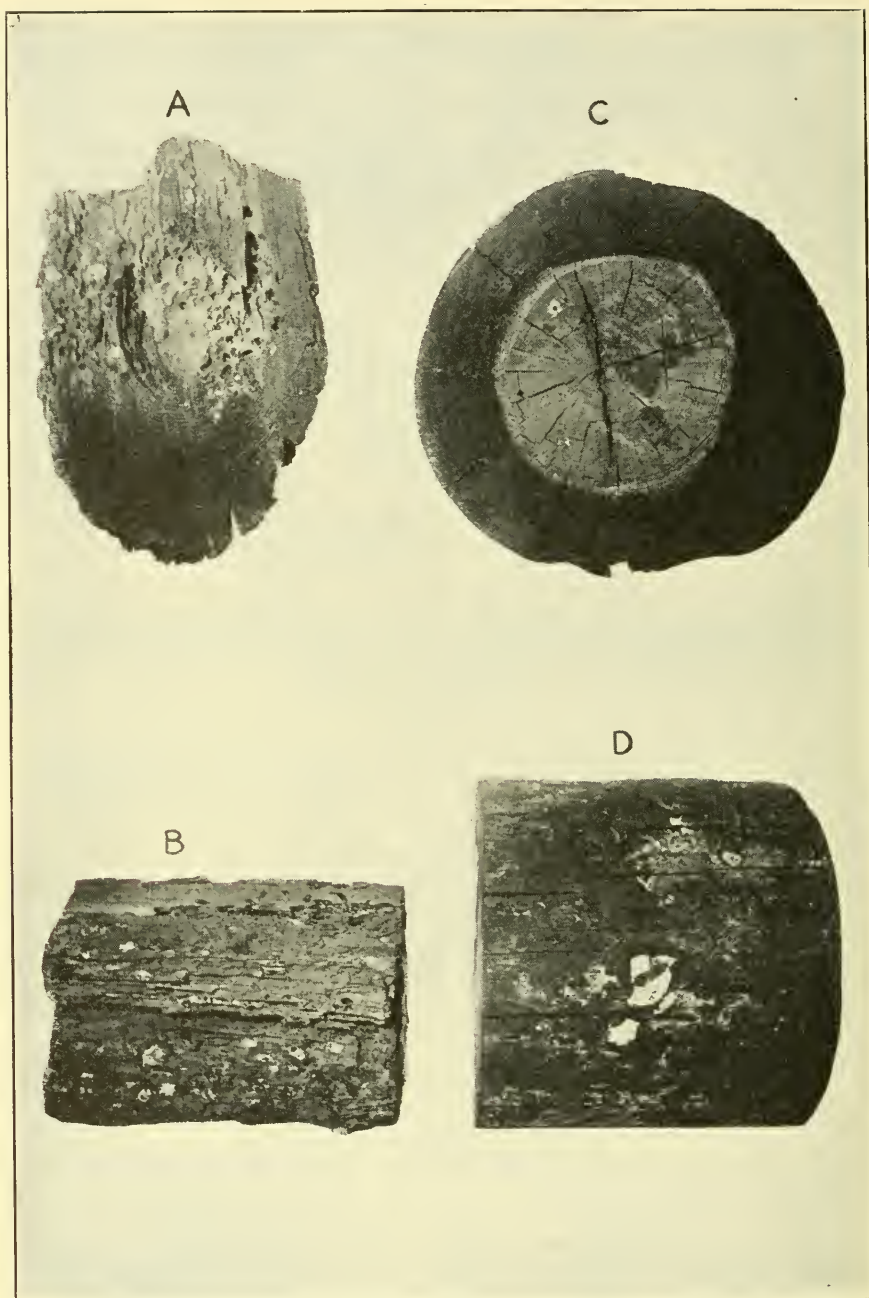
Specimen No. 1—Attacked slightly by *Limnoria* on one side and slightly roughened in few spots possibly by contact with boats. The pile otherwise was in an excellent state of preservation. The specimen had evidently developed slight cracks since it was cut. There were no borer holes. (Fig. 30.)

Specimen No. 4—A large portion of this pile had been eaten away by *Teredo*. Both the heart wood and the creosote layer were seriously attacked and the specimen was very reticular in structure. It was in a poor state of preservation. (Fig. 30.)

FIG. 30.—PILE SECTIONS FROM TURTLE RIVER DOCKS, SOUTHERN RY.,
BRUNSWICK, GA.

A. B.—Pile driven in 1909.
C. D.—Pile driven in 1913.

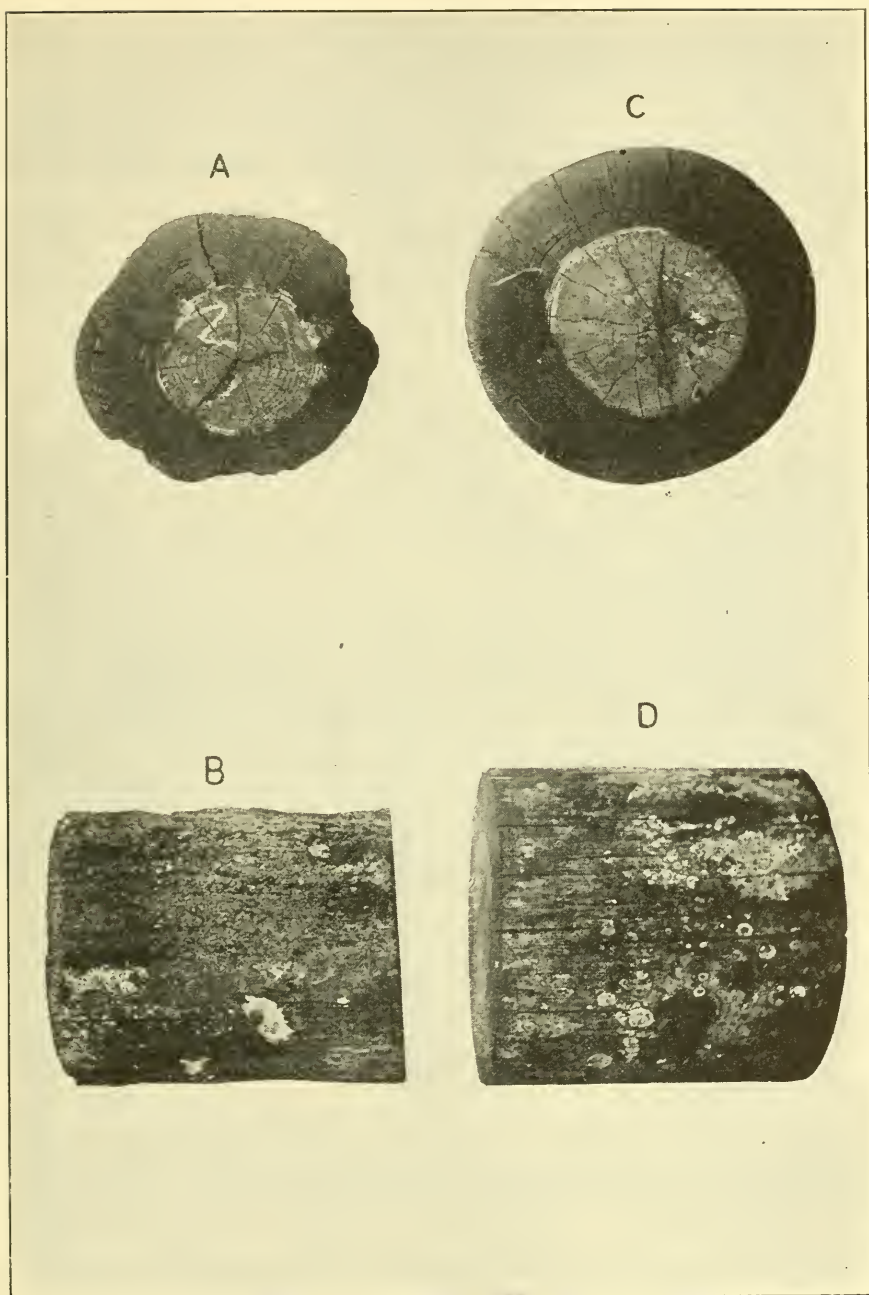
Specimen No. 2—This pile had not been attacked either by *Limnoria* or *Teredo*. With the exception of slight cracks which had developed since the specimen was cut, it was entirely smooth and in an excellent state of preservation. (Fig. 31.)

contained a few borer holes. Its surface was considerably indented from the results of the attack by *Linnoria*. (Fig. 31.)

FIG. 31—PILE SECTIONS FROM TURTLE RIVER DOCKS, SOUTHERN RY.,
BRUNSWICK, GA.

A. B.—Pile driven in 1913
C. D.—Pile driven in 1909

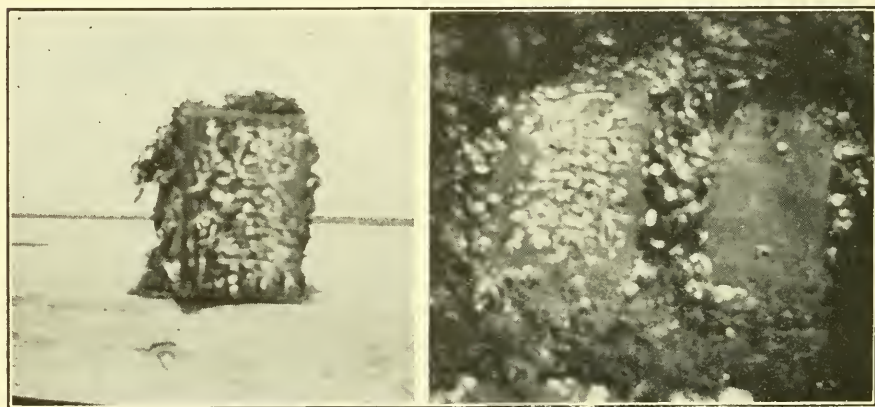
The accompanying small photographs demonstrate that the shipworm will cross a crack. (Fig. 32). The block (left) was removed from the base board (right) after three months' exposure. The face of the block in the picture shows distinctly that the borers passed through the base board into the block. It was observed at the Bureau of Fisheries Laboratory that shipworms frequently crossed gaps of at least 1/16-inch from one piece of wood to another, which fact shows the fallacy of the old belief that the *Teredo* will not cross a crack.

FIG. 32—SHOWING THAT SHIPWORMS WILL CROSS A CRACK

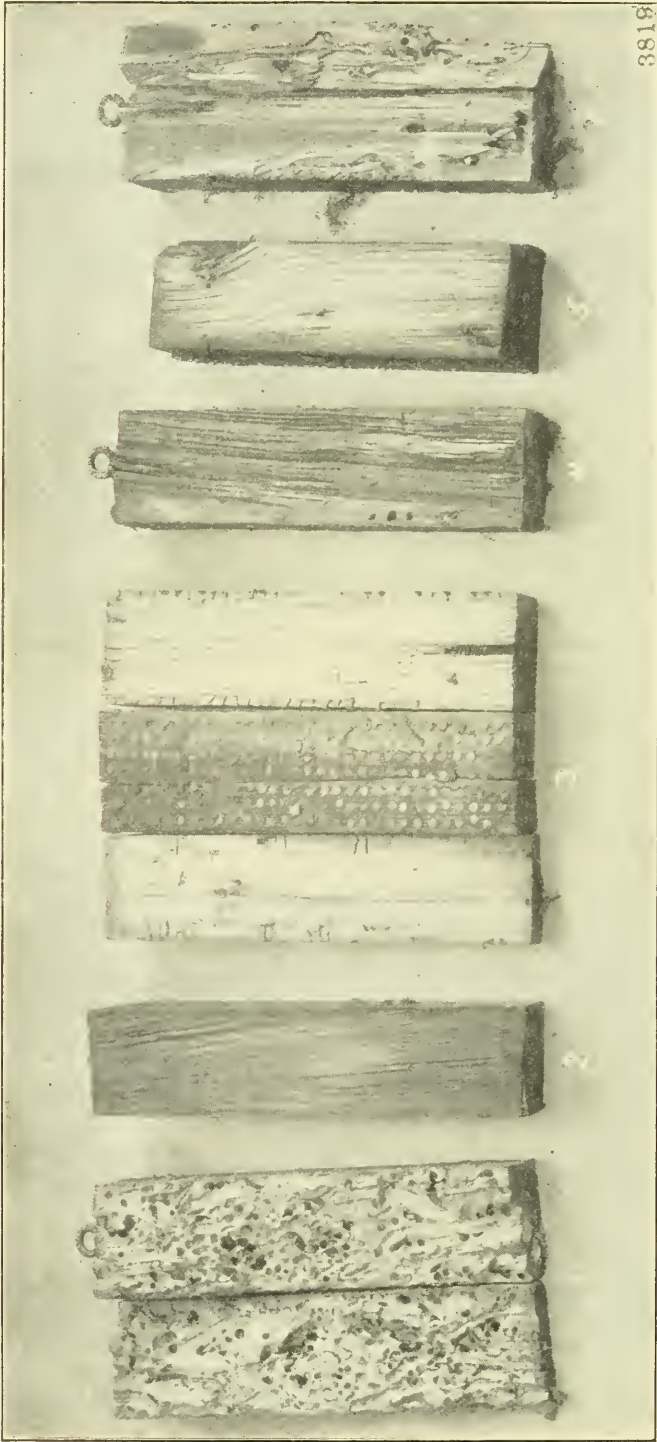
FIG. 35—DETAILS OF SECTIONS OF TEST PIECES AFTER EXPOSURE (ONE-FIFTH ACTUAL SIZE)

- 1—Blank—no impregnant used.
- 2—Aczol impregnation.
- 3—Copper studded pieces.
- 4—Straight creosote impregnation.
- 5—Crystal violet.
- 6—Sulphur impregnation.

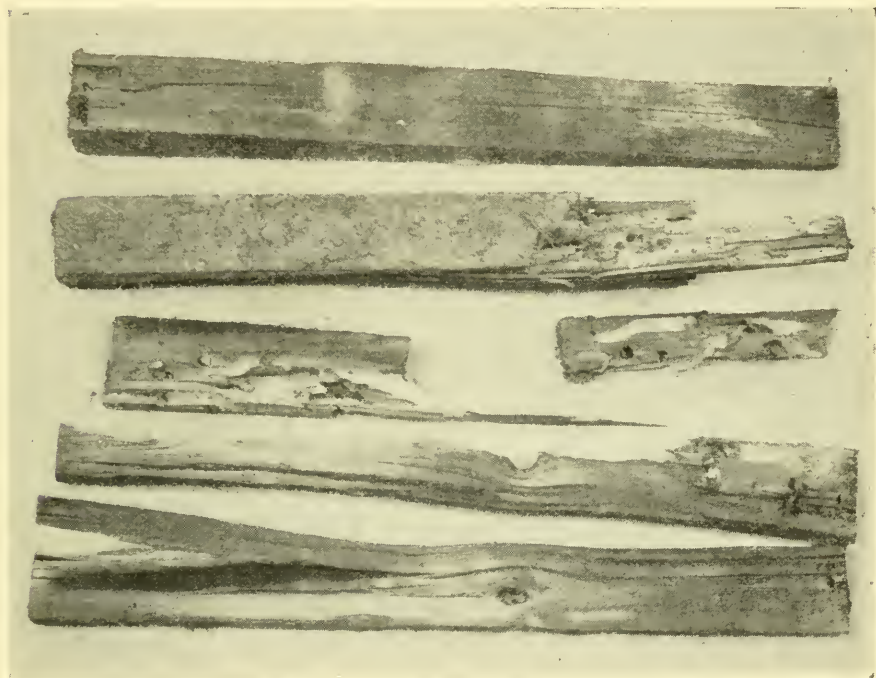
FIG. 36—DETAIL OF ATTACK ON CREOSOTED TEST PIECE

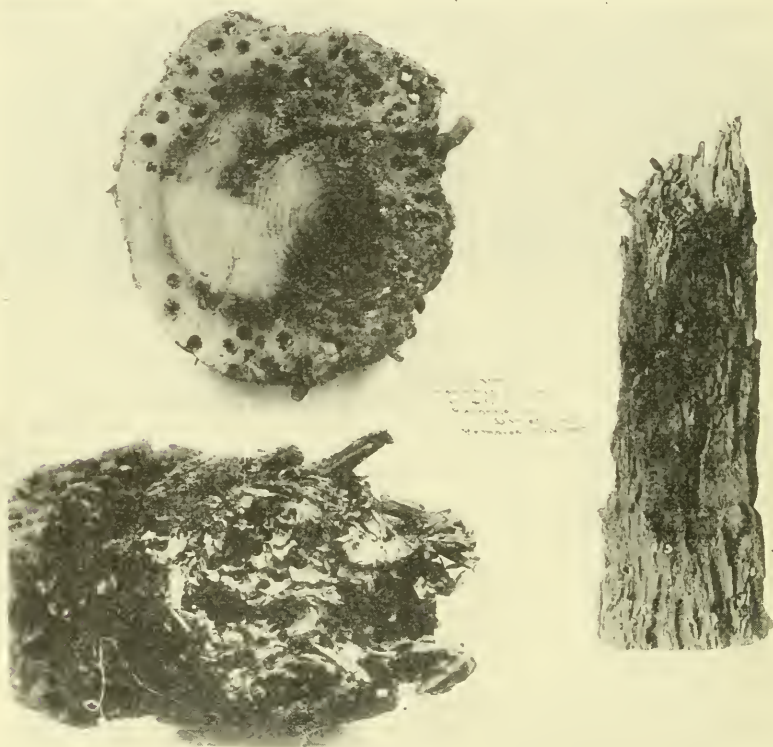
Pier 6, Standard Oil Company, Bayonne—Live specimens of *Teredo* were not found, but the borings were recent and some of the piles were practically destroyed by *Limnoria* and *Teredo* in five years, (Fig. 66).

FIG. 66—SECTION FROM A PILE DRIVEN IN STANDARD OIL PIER NO. 6, BAYONNE, N. J., IN 1915 AND REMOVED IN 1922.

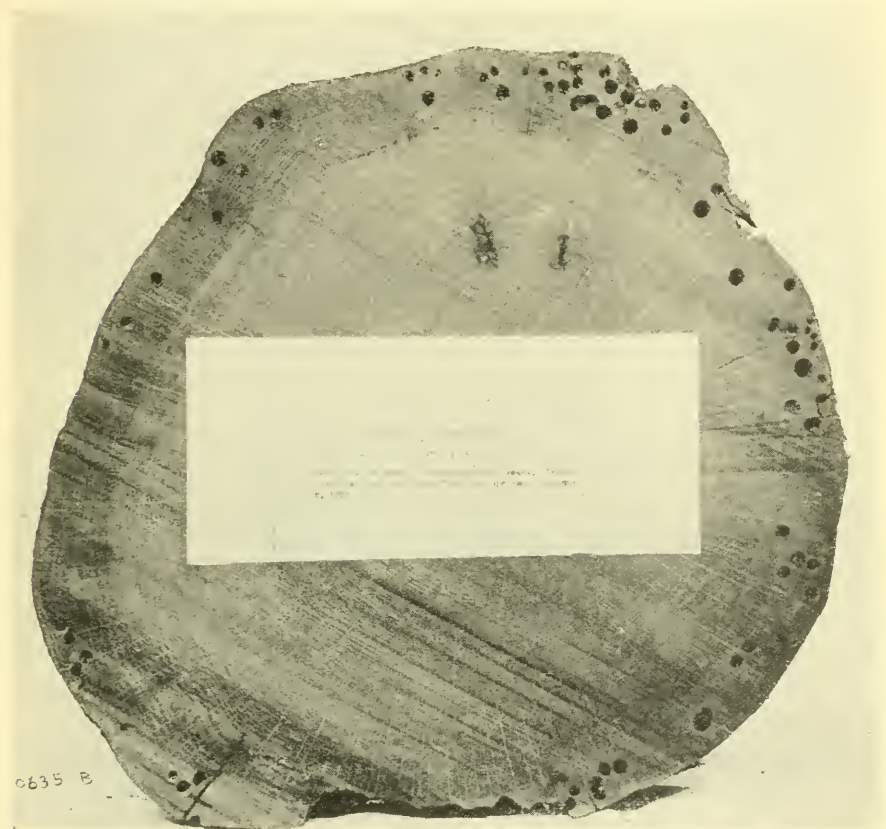
FIG. 67.—SECTION OF PILE FROM LEHIGH VALLEY RAILROAD PIER A, JERSEY CITY
FROM WHICH LIVE *Teredo Navalis* WERE EXTRACTED

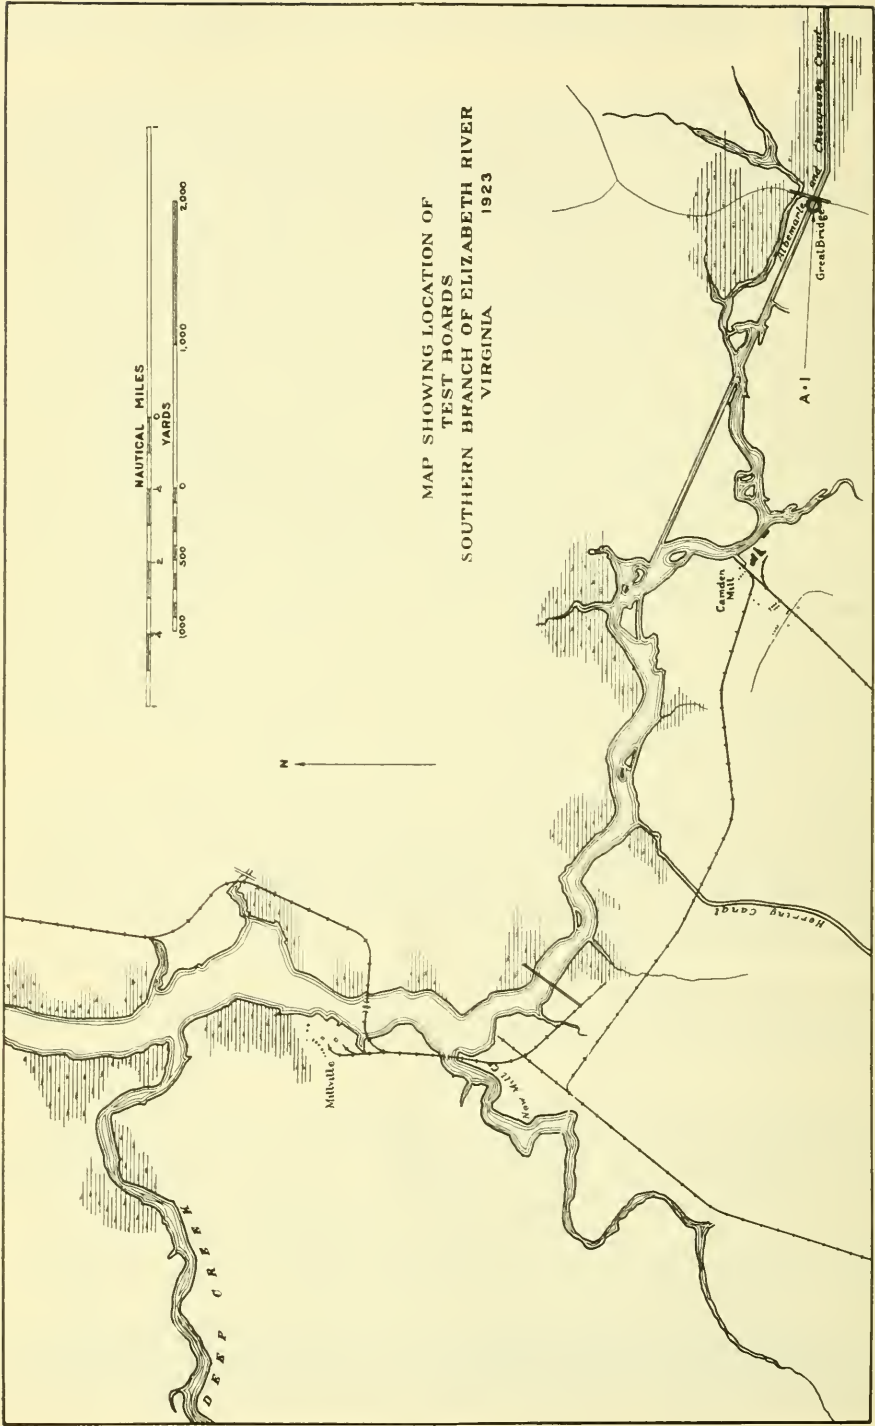
FIG. 86

A-1, (Fig. 86)—Twenty-five blocks were examined, of which blocks 2, 6, 8, 9, 10, 14, 15, 17, 20, 21 and 22 each contained one specimen of *Bankia gouldi*. Associated organisms were *Balanus*, *Mytilus*, Bryozoa and numerous non-boring crustacea.

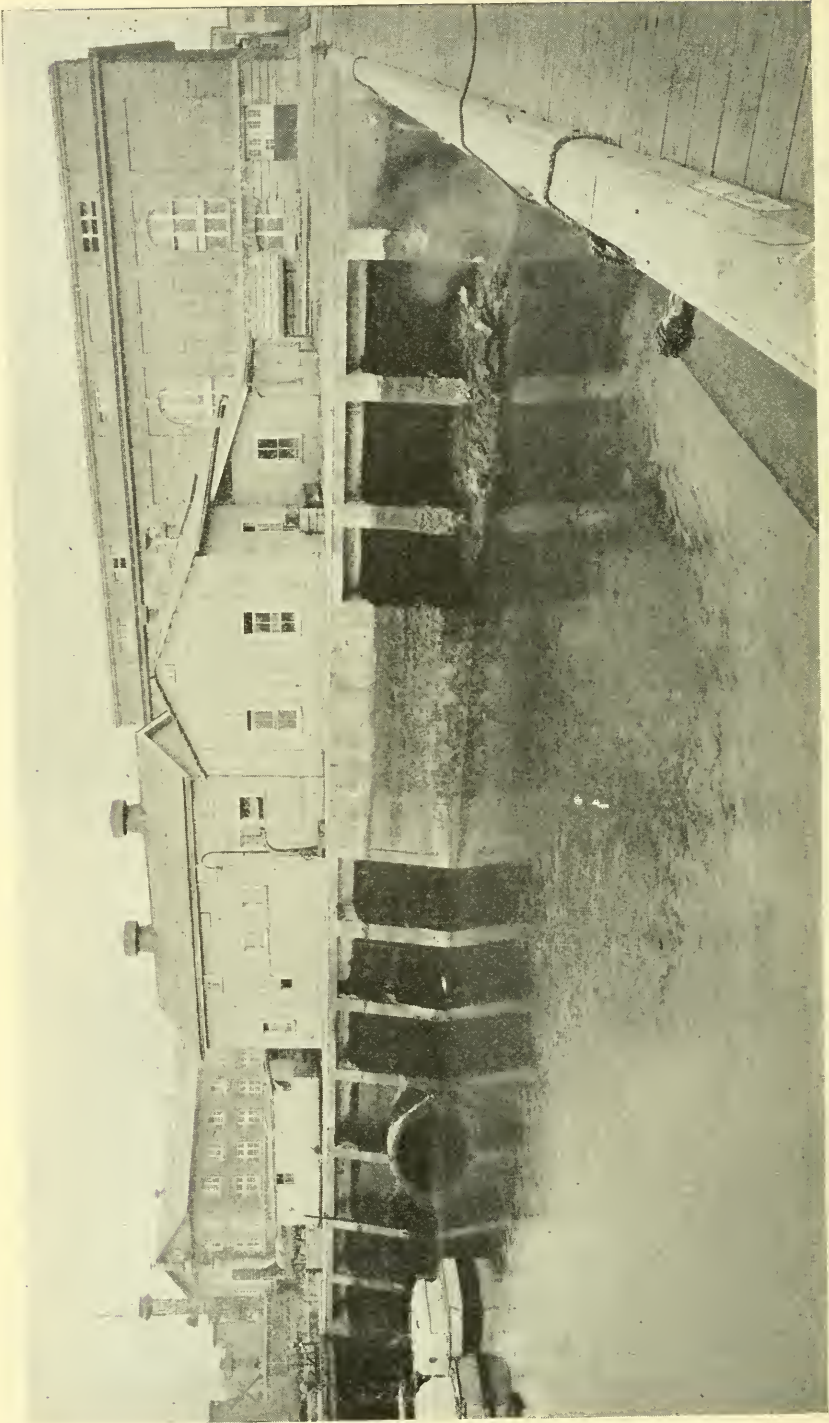
The mixture was 1:3:6 with a 1:2 mortar facing. The lower 6 feet of the wall was placed in the dry, but the tide frequently covered the remainder, which was carefully cleaned and grouted before recommencing work. The wall has been repaired at various times, and in March, 1923, showed considerable deterioration.

FIG. 144.—SEAWALL SECTION, PUGET SOUND NAVY YARD, SHOWING CONCRETE DISINTEGRATION

Several other walls and structures are reported, but generally of the same type of construction and in about the same condition (Fig. 144).

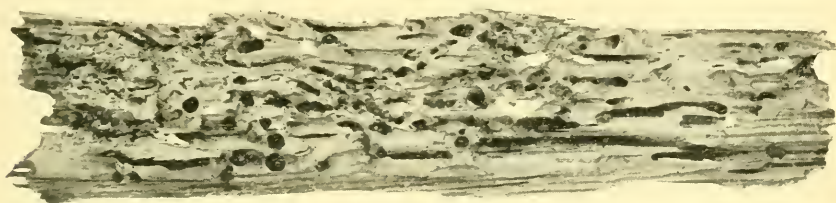
Since the preparation of this report Mr. R. T. Betts, chairman of the committee, received from Mr. Allen Spooner of Allen N. Spooner & Co., Inc., a section of the pine timber cover plates from the outlet nozzles of the Passaic Valley sewer, which terminates in the channel near Robbins Reef Light in a depth of 40 feet below mean low water.

Mr. Van Duyne, Chief Engineer of the Passaic Valley Sewerage Commissioners, states that this timber was new when installed and that it has been in place not more than four years. The cover plates were tem-

FIG. 169—SECTION FROM COVER PLATES OF PASSAIC OUTLET SEWER NEAR
ROBBINS REEF LIGHT, NEW YORK HARBOR

The section shown in the illustration (Fig. 169) is from the plank joining the cover plates and was removed May 31, 1924.
